# Making the Most of a Siding Replacement Job

A re-siding job offers a rare opportunity to upgrade a home's air-sealing and insulation

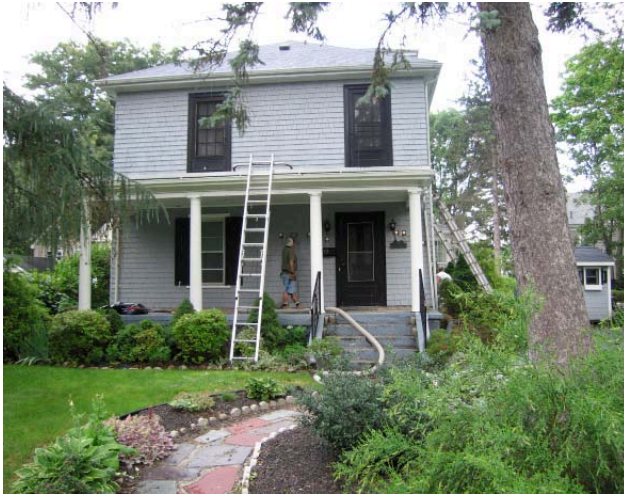
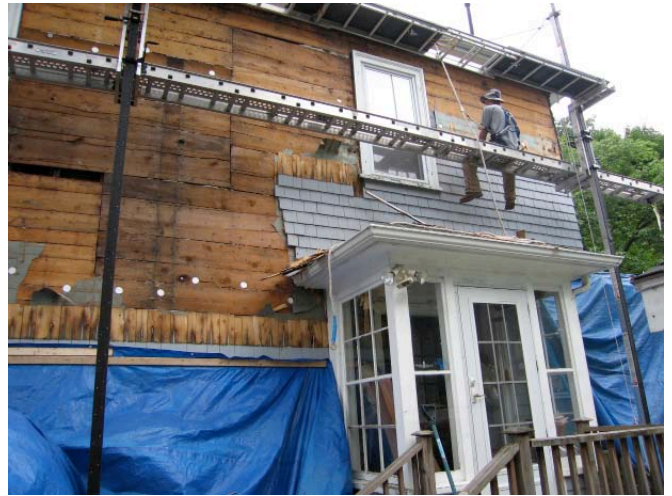
**Figure 2.** The wall cavities were first dense-packed from the outside with blown cellulose insulation (left). Then the crew stripped off the old cedar shingle siding, focusing on one side of the house at a time to make it easier to protect the house and insulation from the weather (right).

Our insulation sub installed the cellulose at a density of at least 3.5 pounds per cubic foot, giving the walls a solid R-13 or more

worth of insulation (Figure 2). Though not technically an air barrier, dense-pack cellulose reduces air movement both through and within the wall, which gave us a good head start at air-sealing. After the cellulose was installed, we performed another blower-door test and found that we'd decreased the air-leakage rate to 2,550 cfm50, or a little less than 7 air changes per hour. This isn't tight enough to require mechanical ventilation, but not bad considering that we hadn't done any air-sealing or insulating in the attic. The house was also noticeably quieter.

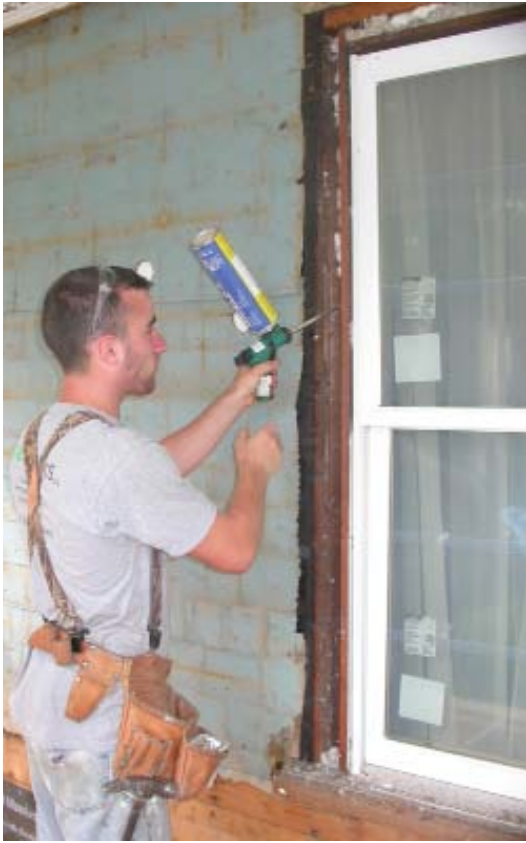
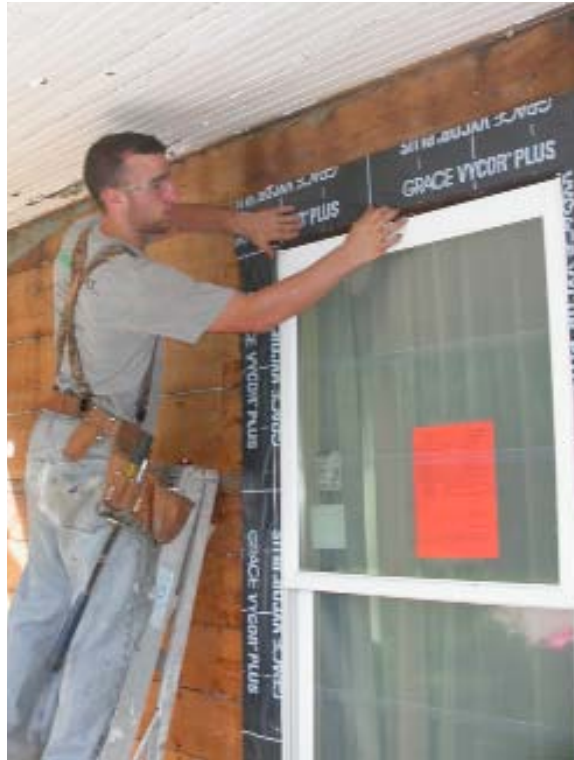
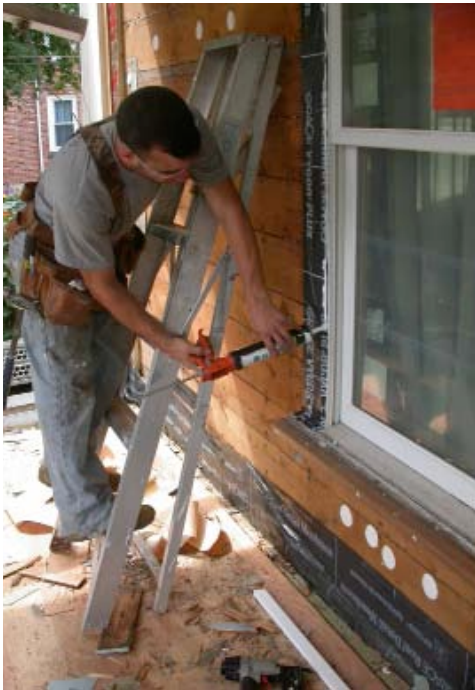
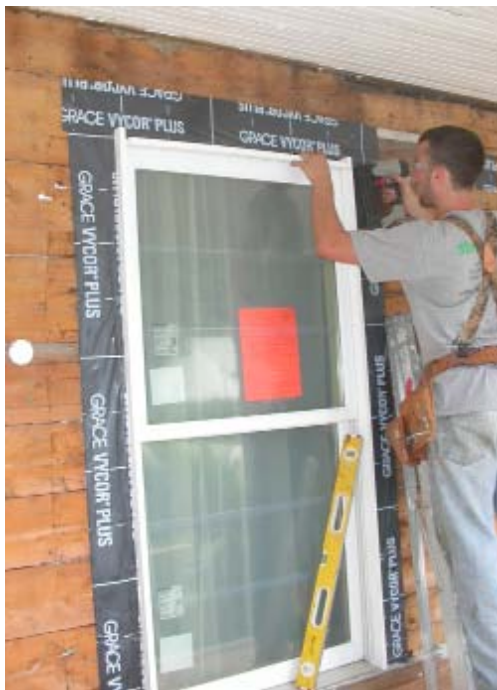
**Figure 3.** After removing trim from the old windows (this frame was fitted with new jamb liners and replacement sash), crew members filled voids and gaps around the frames with spray foam (A), then taped the frames to the sheathing with self-adhering flashing tape (B). New cedar sill extensions were applied to the sills (C), while the frames were fitted with new 1<sup>3</sup>/<sub>8</sub>-inch-wide Azek jamb extensions (D).

We filled small voids around the windows — like sash weight pockets — with spray foam (Figure 3). Then we sealed the window frames to the 1x12 sheathing with 4-inch-wide Grace Vycor window flashing (866/333-3726, na.graceconstruction.com), taping the bottoms and legs first. When we taped across the tops of any windows that were exposed to weather, we used wider 6-inch Vycor and left a 2-inch flap (with the release paper backing still attached) hanging down over the head jamb. Later, when we fastened the jamb extensions to the frames, we folded these flaps back, peeled off the remaining release paper, and attached the flashing to the extension. The flaps act as sheathing-level drip caps that keep water out of the joints between the jamb extensions and head jambs.

We ripped jamb extensions from Azek, a low-maintenance cellular PVC product (877/275-2935, azek.com), making them 1<sup>3</sup>/<sub>8</sub> inches wide to accommodate the 1-inch-thick rigid foam and <sup>3</sup>/<sub>8</sub>-inch-thick plywood rainscreen battens that would be added to the wall. We fastened the extensions to the jambs with 2<sup>1</sup>/<sub>2</sub>-inch trim nails and welded their corners together with PVC glue.

The sill extensions were ripped from 2x4 cedar. We beveled them to match the angle of the existing sills and made a shallow relief cut on the underside to serve as a drip edge. Then, after applying exterior carpenter's glue, we fastened them to the sills with 3-inch-long screws driven through predrilled countersunk holes. We filled the holes with Abatron two-part epoxy putty (800/445-1754, abatron.com).

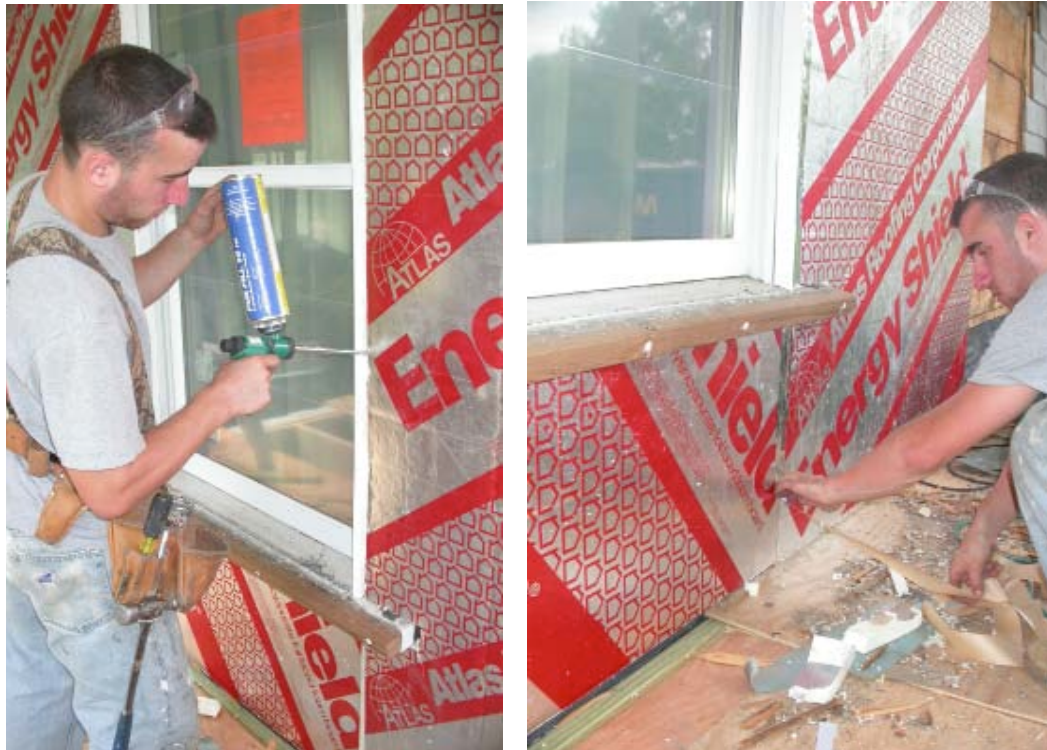
**Figure 4.** The walls were wrapped with 1-inch-thick sheets of polyisocyanurate foam, which adds R-6 to the wall assembly and acts as an air and vapor barrier and drainage plane. All joints — including gaps between the rigid foam and jamb extensions — were foamed (far left) and sealed with flashing tape (left).

In this wall assembly, the rigid foam acts as the air and vapor barrier and as the drainage plane, so we took pains to seal the joints carefully. First, we filled in the nooks and crannies and quick-cuts with spray foam (Figure 4). Then we taped all of the seams with Atlas WRB flashing tape to continue the air-seal.

we could. We filled any gaps between the jamb extensions and rigid foam with spray foam, then covered the joints with flashing tape.

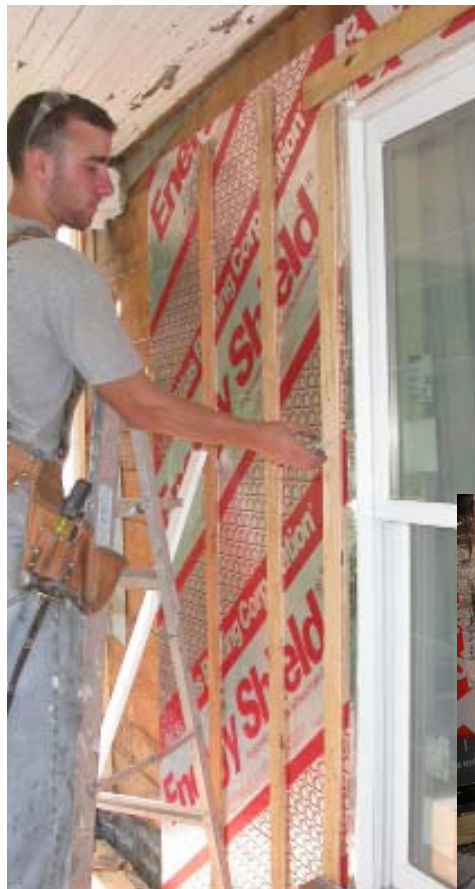
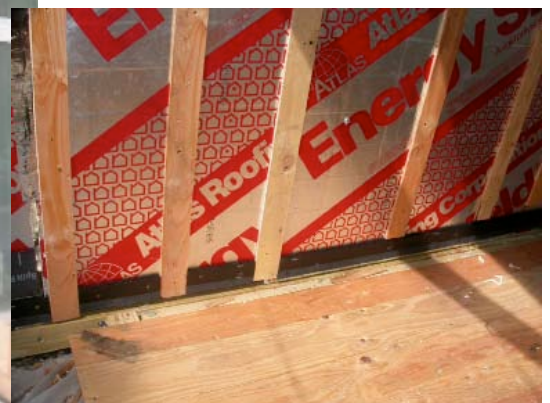
**Figure 5.** Battens ripped from ¾-inch plywood were fastened through the foam and sheathing into the wall framing to provide solid nailing for the fiber-cement siding and create a drying airspace behind it (left). Strips of ¾-inch-thick Cor-A-Vent installed along the base of the wall between the battens keep out insects (B).

We ripped strips of  $\frac{3}{8}$ -inch PT plywood to use as rainscreen battens (Figure 5). Not only will this drying space behind the siding add several years to the paint job, but it allowed us to put up siding during one of the rainiest Junes on record without worrying about trapping moisture underneath.

We located the battens over wall studs and filled the gaps between them along

the bottom edge of the house with Cor-A-Vent siding vents (800/837-8368, cor-a-vent.com). The screened vents prevent insects from nesting behind the siding while allowing moisture to drain and air to circulate.

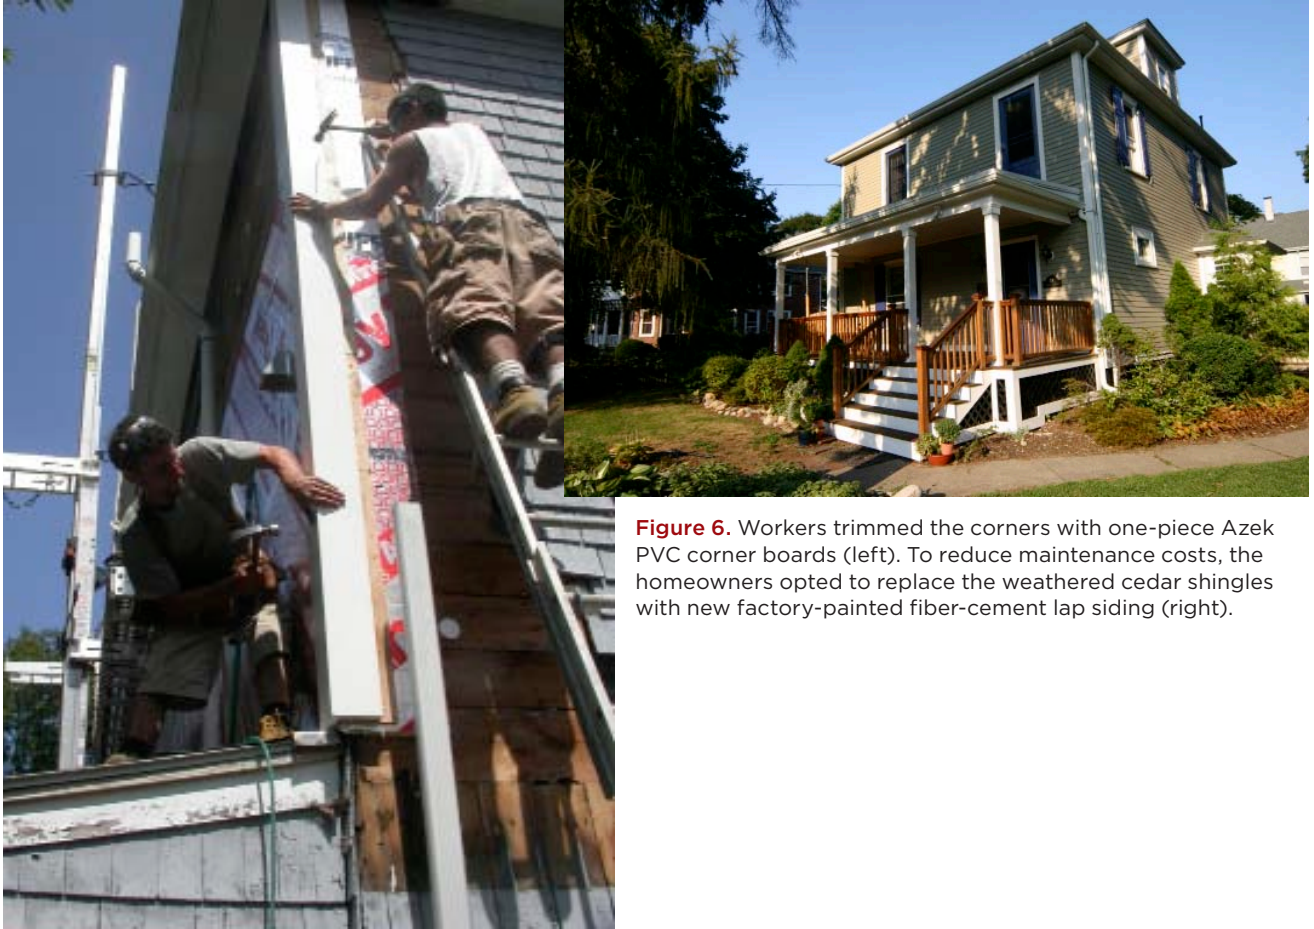
**Figure 6.** Workers trimmed the corners with one-piece Azek PVC corner boards (left). To reduce maintenance costs, the homeowners opted to replace the weathered cedar shingles with new factory-painted fiber-cement lap siding (right).

Though we repaired a few rotted windows with epoxy, we replaced most of the window and door casings with 1x5 Azek PVC trim. At the corners, we installed preformed Azek 5/4x6x6 corner boards, a one-piece product that should do a better job of blocking water than the 5/4x6 fiber-cement trim boards we've used in the past (Figure 6). Besides being very heavy and

Finally, we installed 5¼-inch HardiePlank fiber-cement siding with a 4-inch exposure. With a single coat of factory-applied paint, HardiePlank has a 15-year finish warranty (a second coat extends the warranty to 25 years). We nailed the siding up with 3-inch stainless-steel ring-shank siding nails, which were long enough to penetrate through the PT plywood and foam into the sheathing and studs. Over the header trim on the windows we nailed standard aluminum window flashing directly to the battens before installing the siding. We caulked between the siding and the trim with Geocel ProColor SWD sealant (800/348-7615, geocelusa.com) color-matched to the HardiePlank.
